# SOLVING ROOF AND BALCONY LEAKS IS NOT JUST ABOUT WATERPROOFING

BY PAUL EVANS, MANAGING DIRECTOR OF FINDLAY & EVANS WATERPROOFING, PRESIDENT OF THE AUSTRALIAN INSTITUTE OF WATERPROOFING (AIW), AND REGISTERED BUILDING PRACTITIONER

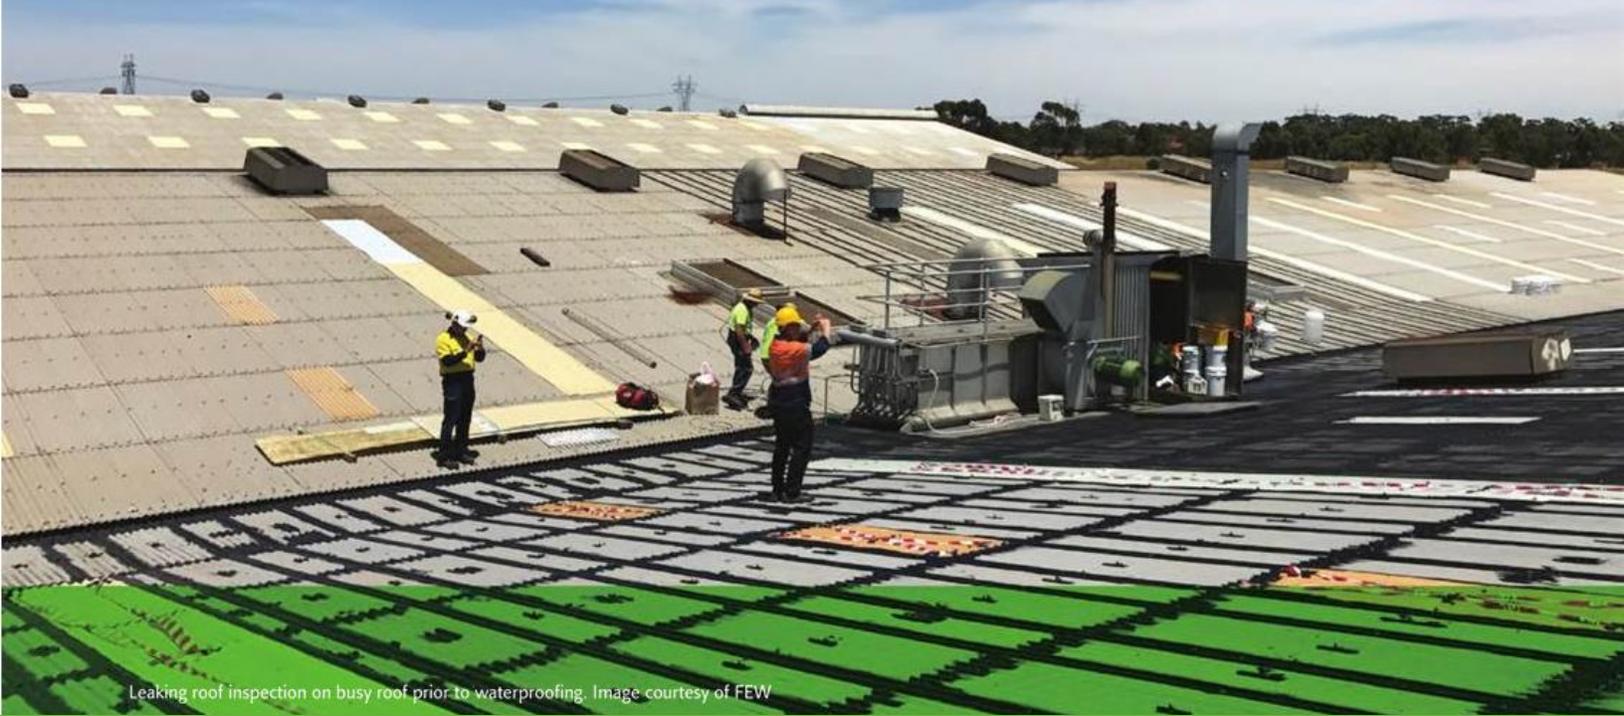
Leaking roof inspection on busy roof prior to waterproofing. Image courtesy of FEW

membrane need the costly and time-consuming option of total removal'? This is particularly relevant with 'busy' roofs, such as those with mechanical installations and rooftop plant deck equipment.

This is where my so-called 'roof forensics and assessment' comes into play - knowing the root cause of water leaks goes a long way to

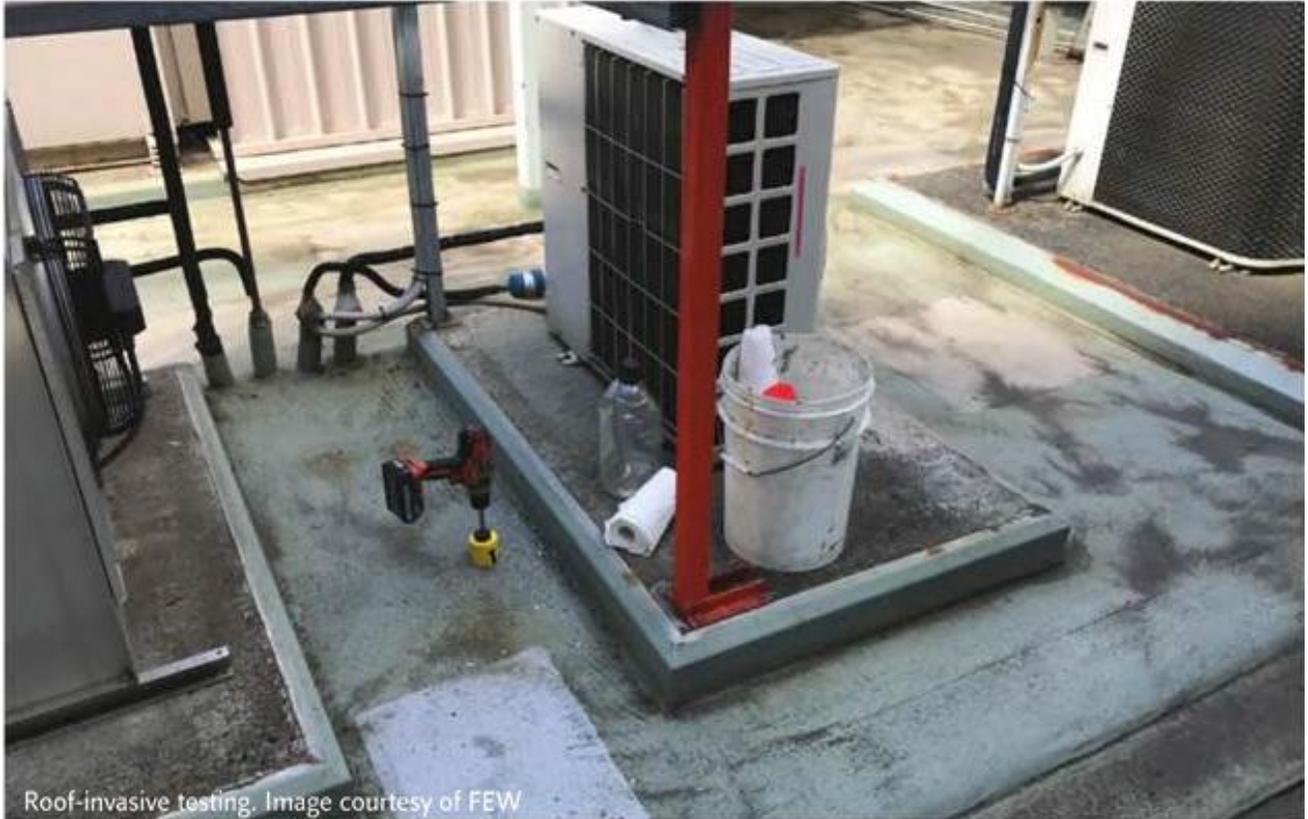
Leaking balcony. Image courtesy of FEW

Leaking balconies are a completely different matter. We see many balconies leaking due to poor design, inferior construction methods, incorrect waterproof application and failed balcony finishes - which mostly involves tiles.

I would like to delve deeper into this last cause of balcony water leaks, as many as professionals are unaware of the relationship between balcony tiles and water leaks. If tiles are not installed correctly on a waterproof membrane, they will make a perfectly good membrane leak.

There are, however, structural methods to cope with this movement. Expansion joints, rather a lack of thereof, are probably the most common cause of a failed balcony – surprisingly, not the waterproof membrane itself. Or, if tile adhesive is too ridged or the membrane lacks flexibility, balcony cracking is inevitable – and with cracks, you get leaks.
